STUDY REPORT

SR 233 (2010)

Investigation into the Performance of Urea Formaldehyde Foam Insulation

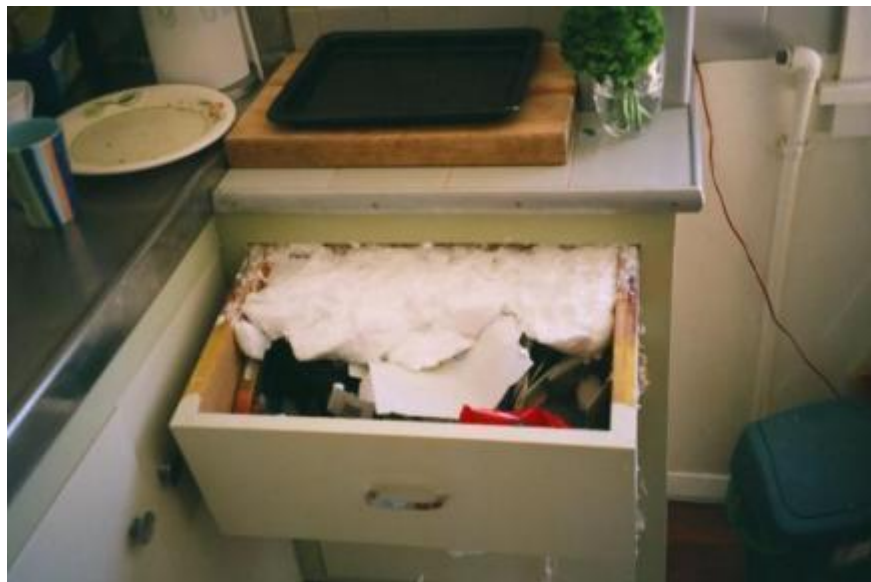
Although there have been a few reported cases where the Airfoam installation process has been problematic, such as in the case observed in Figure 1 and Figure 2, it appears that these cases are relatively rare occurrences. These issues are usually a result of installer error or lack of robust assessments prior to installation.

Figure 1: Example of serious installation problems (House W7)

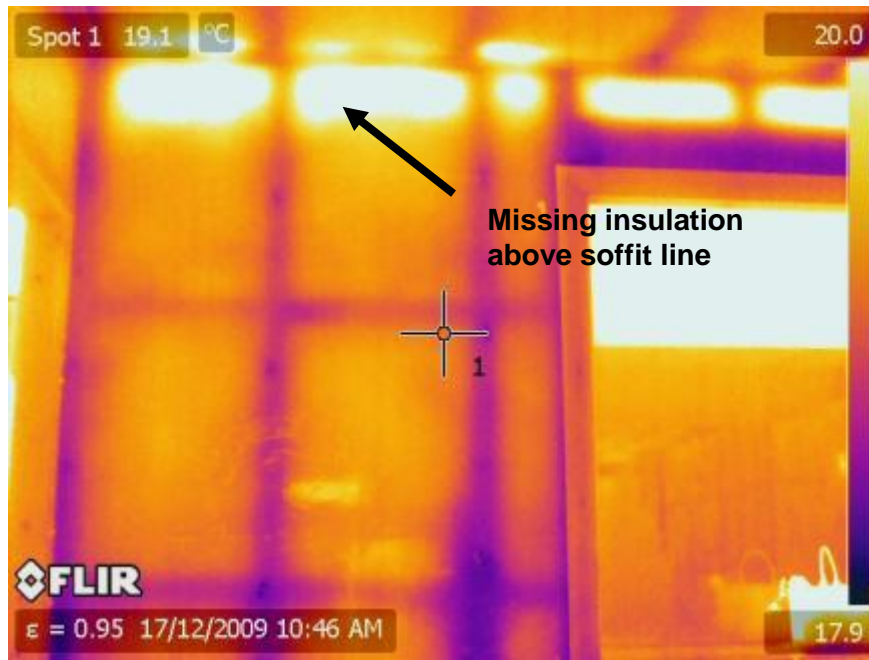
Figure 4: Thermal image identifying missing insulation in another upper wall above the soffit line (House C7)

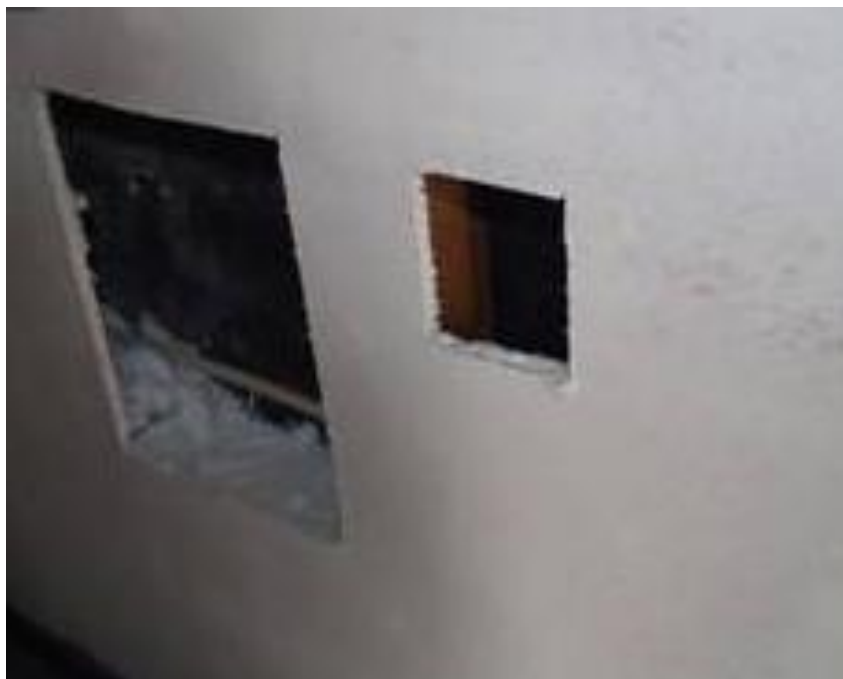
Figure 8: Removal of wallboard confirms missing insulation (House W4)

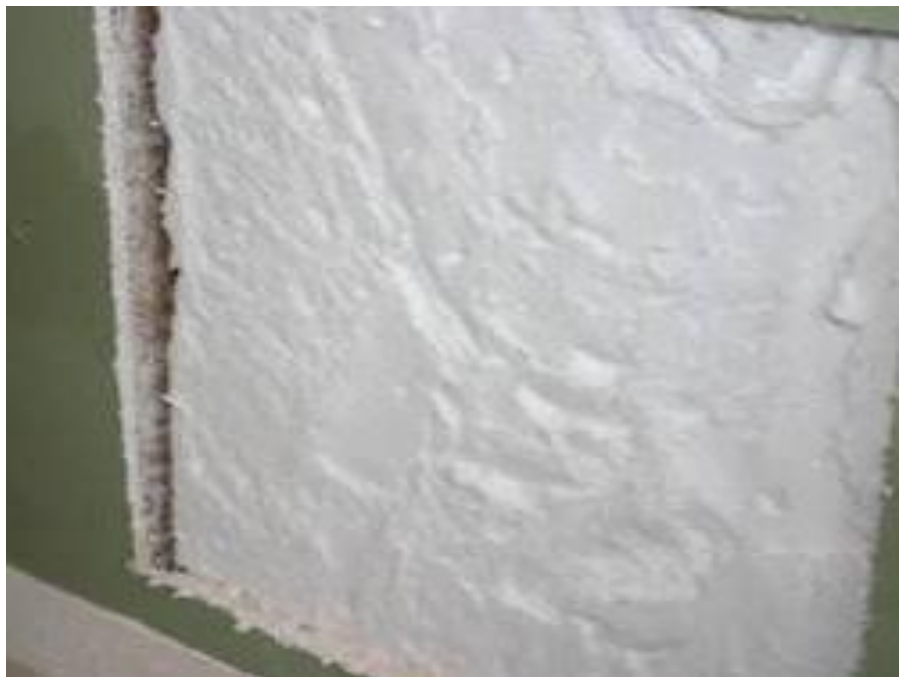
Figure 11: Removal of wallboard to assess Airfoam installation (House W3)

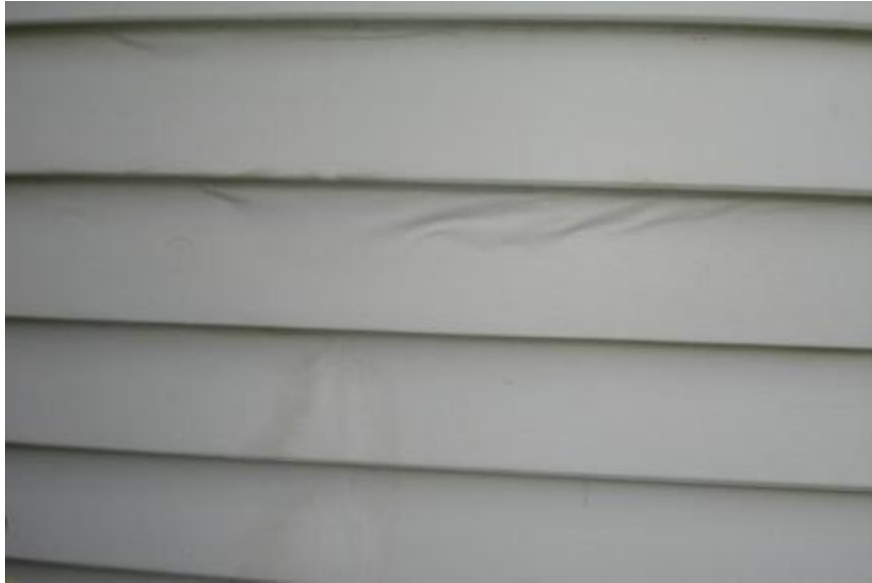
The homeowner stated that the house also had issues with blistering and peeling paint on the weatherboards, as well as a bulging tongue and groove internal lining resulting from the installation of the Airfoam. Some of these issues had since been rectified by the installer. The moisture content of the timber was very high in some places and it was clear the property had some moisture issues unrelated to the installation of the Airfoam insulation. Although the Airfoam was not the main cause of the moisture problems, the high volumes of water evolved during installation processes could have exacerbated the issue.

Figure 12: Blistering paint on weatherboard, evident after Airfoam installation (House W3)

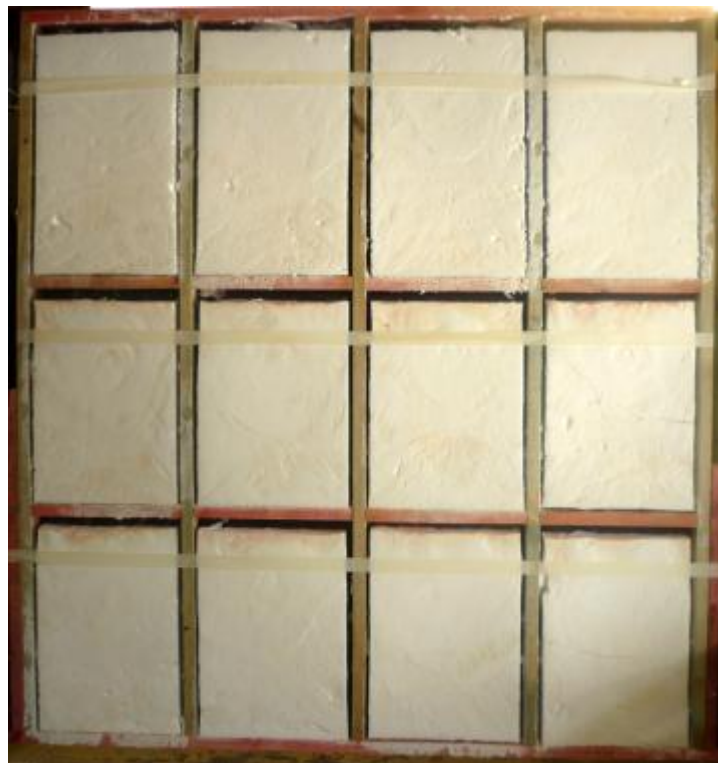
UF foam was injected into the insulation cavities, behind the building underlay, from the outside, using holes drilled through the weatherboard by an Airfoam applicator in December 2009. The specimen was then stored in the BRANZ laboratory for five weeks until being tested in mid January 2010 (Figure 13 and Figure 14).

Figure 14: Test wall (D4861) after Airfoam installation and plasterboard removed

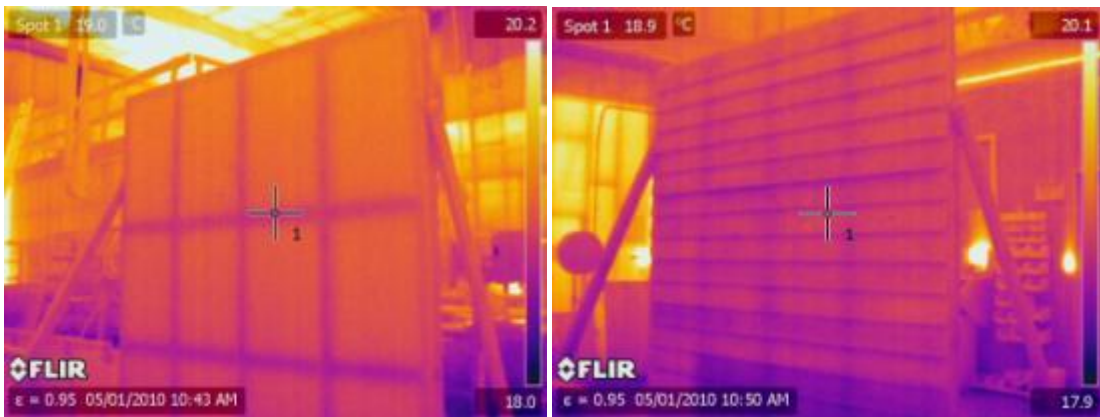
As a demonstration of the effects that shrinkage gaps can have on the thermal performance, a further 2.4 m by 2.6 m panel was constructed (designated wall D4862) and tested that was identical to the first except an R 2.8 glasswool insulation product was used instead of Airfoam. In the first of two tests (D4862a) with the panel the insulation was well fitted without gaps, whereas for the second test (D4862b) gaps representing 6% of the insulation width were deliberately created at the sides (3% either side) and top (6%) of each frame cavity. However unlike the Airfoam panel, which was expected to have shrinkage gaps between the face of the insulation and the inside face of the cladding and lining, gaps were only created around the edges of the glasswool and not against the faces (shown in Figure 17 to Figure 21).

Figure 17 & 18: Thermal images of panel (D4861) immediately before thermal testing

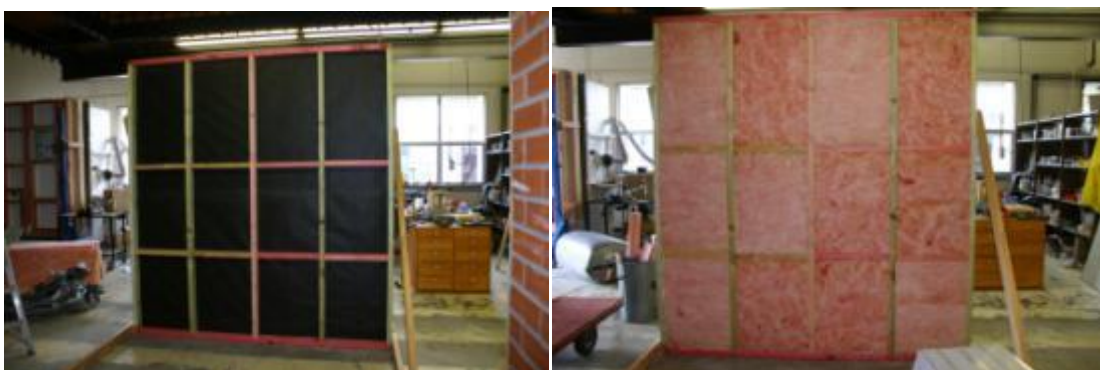
Figure 19 & 20: Frame before insulation (D4862) and with well fitted R 2.8 glasswool insulation (D4862a)

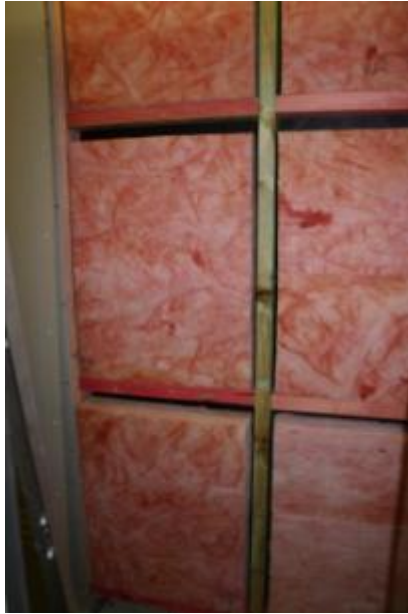
Figure 21: R 2.8 glasswool insulation fitted with 3% gaps at side and 6% gap at the top of each frame cavity (D4862b)

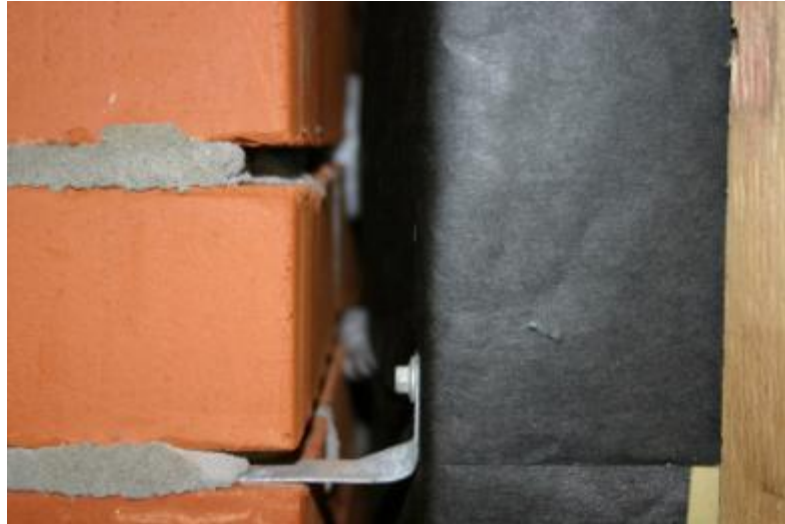
The wall sample (D4863) had a layer of black kraft paper installed against the cavity face of the framing and standard 10 mm plasterboard fixed to the other face (Figure 22). UF foam was injected into the insulation cavities, behind the building underlay, from the outside, using holes drilled through the mortar joints of the brick veneer by an Airfoam applicator on 12 February 2010. The specimen was then stored in the BRANZ laboratory for seven weeks until being tested for thermal performance in the Guarded hotbox from 1 to 14 April 2010.

Figure 22: Cavity of Brick Veneer Wall (D4863a)

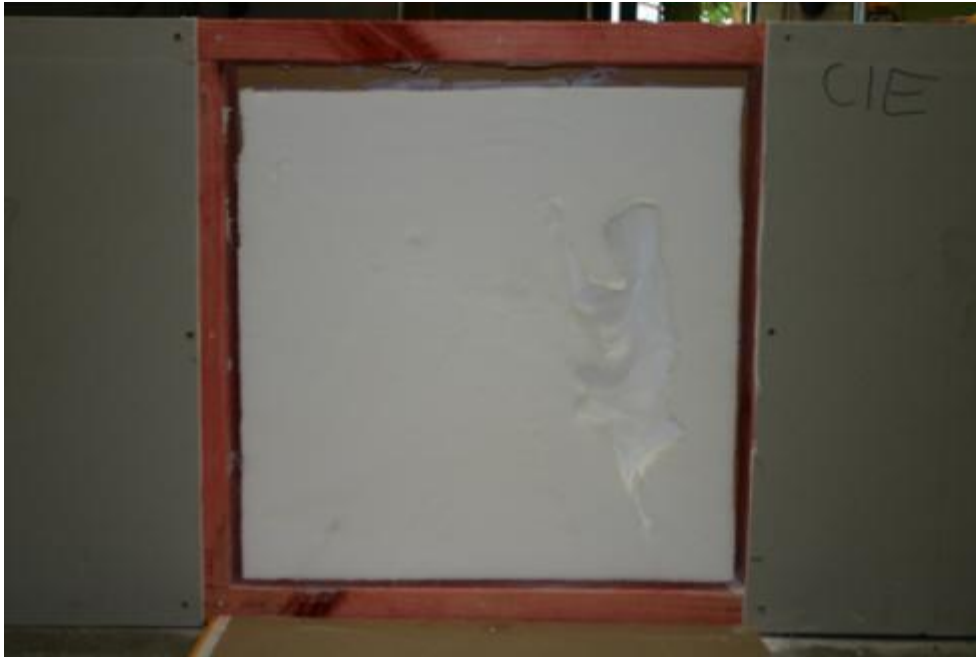
The dimensions of the fully cured UF foam in the cavities of the low walls designated C1 and C2 were also measured. The shrinkage of the samples from the rigid tubes prepared in February 2010 was measured following NZS4235 / BS5617. An average linear shrinkage of 8.97% was obtained on samples with an effective density of 11.86 kg/m³.

Figure 24: : Shrinkage in low wall C1, specimen C1D.

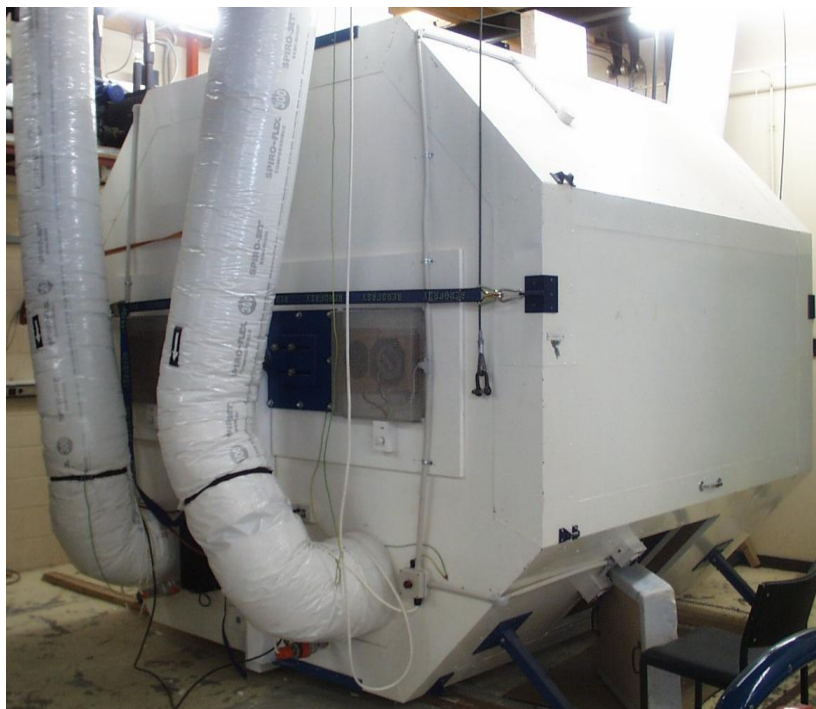
The thermal performance test for an Airfoam insulated wall was carried out using the BRANZ Guarded Hot Box (GHB), which consists of two insulated chambers of approximate face area 2.4 m x 2.4 m, with an internal depth of 1.2 m. The apparatus is constructed and operated according to ASTM C1363-97. The final R-value is determined by averaging the measurements over at least 24 hours (See Appendix 7.2 for further details).

Figure 30: Guarded Hot Box
